## Boat Slaves

By Rae Simpson August 2021

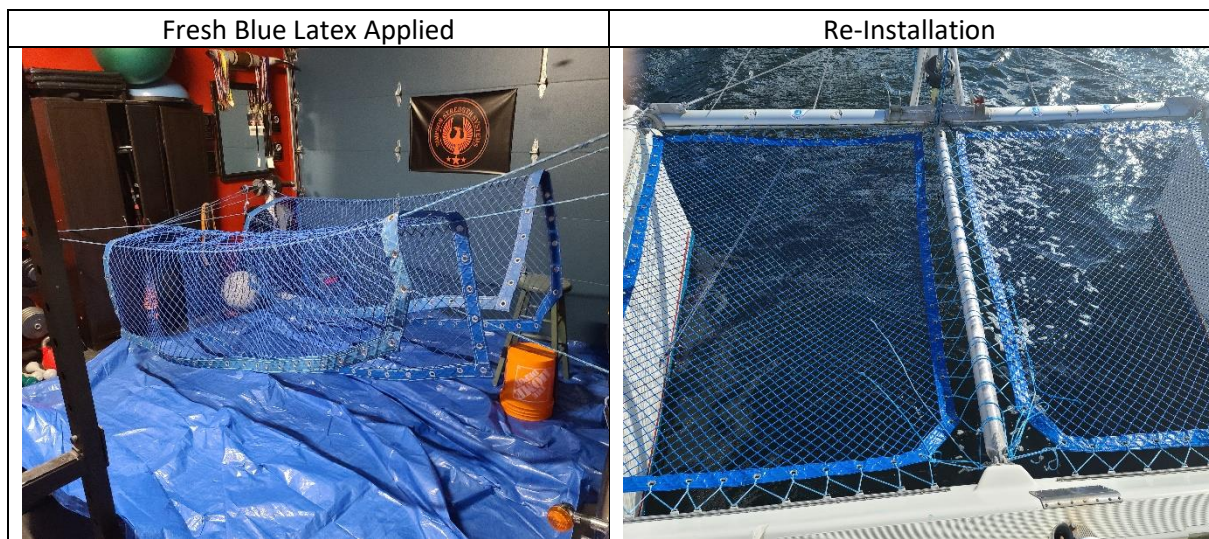
First up was an R&R on the tramp. Early spring my partner Sharon and I removed it, repainted it with a nice bright blue latex. Replaced all the slides and a few of the rivets. Then re-installed, trying out some slippery new dyneema line. Each side is one continuous line. Looking much refreshed and much safer.

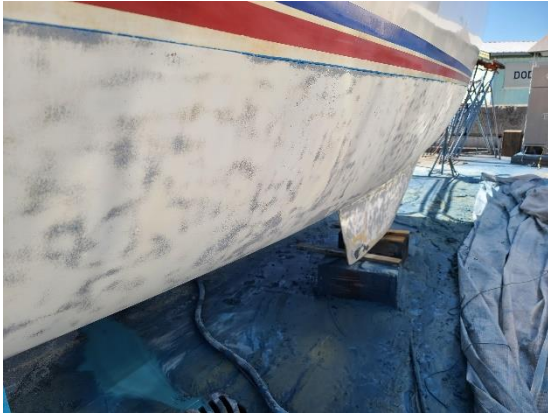
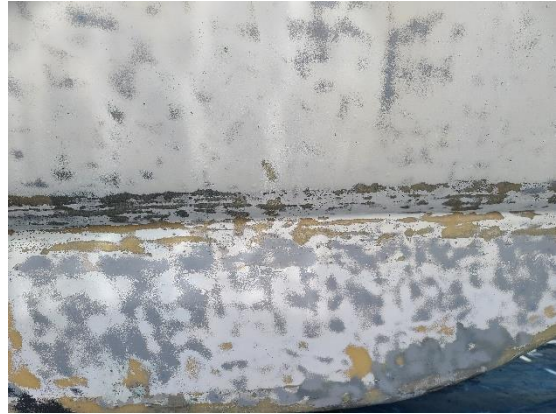
### After the Blast

Sanding old bottom paint is my favorite activity – said nobody ever! I read about a soda blasting technique which media from the eastern USA were raving. Seemed a good idea and an escape from sanding. I just had to throw money at it and presto bottom paint gone. Somehow between Marine Blast and me - soda blast became sand blast. That stripped the bottom paint off just fine. Along with the bottom paint came 90% of the previous barrier coat and 20% of the gelcoat. Did I mention the hundred or so tiny holes in the gelcoat?

It was nothing to do with the blast but, a half dozen blisters at the secondary joint where the mini-keels joined the hull emerged. These swelled up as the sun heated the hulls but were otherwise invisible. The hulls are vacuum bagged closed cell foam so a little water won't hurt them. It seemed like the resin did not get sucked into 100% of the gaps in the foam, then - over time, water wormed its way in to a few of those gaps.

Ok, head down, get going, grind or drill, mix and fill, sand and fair. Repeat ad nauseum. Half a dozen of the small gelcoat holes leaked a stinky clear fluid. These were flared out, dried out, filled and faired. The big blisters were ground out, vacuumed, dried out, filled with epoxy, and faired. Respect to Ron Tomas who helped with materials, tools, and technical advice.

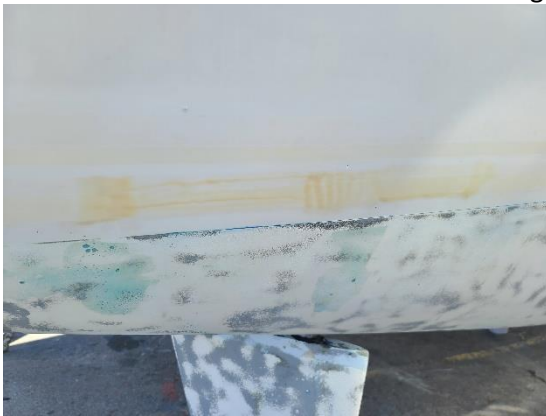
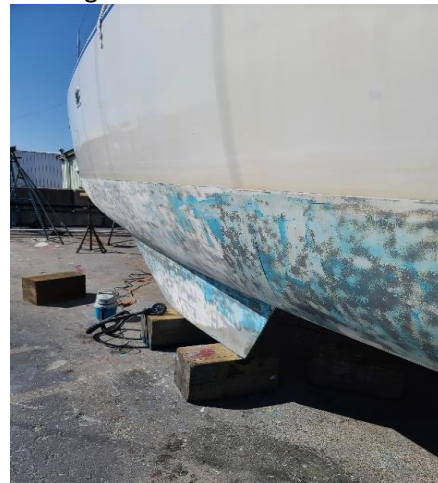
### Filling and Fairing

After two weeks, things were looking pretty good, so we applied the first barrier coat which revealed minor flaws in my fairing. Back to filling and fairing. This was now four weeks on the hard.

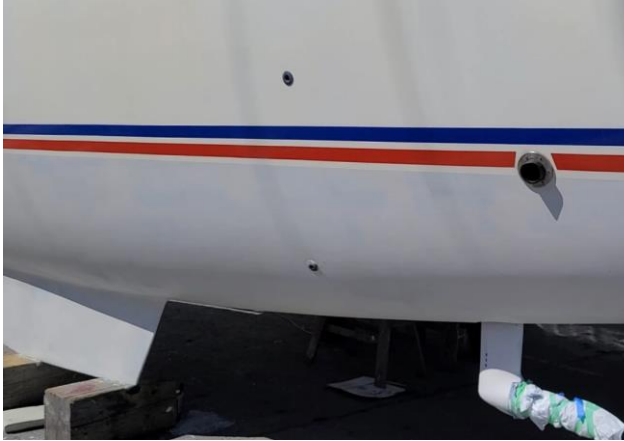
New Stripes and the Fifth Barrier Coat

In parallel with the floorboards and dodger work, we used stripe remover wheels to lift the scratched up and faded old lower vinyl hull stripes. We laid down fresh bright red and blue stripes. Under those stripes, we put on a total of five Interprotec epoxy barrier coats. Those will seal the hull watertight for the next 20 years or so. We also changed the oil in the legs, replaced all zincs, inspected the rudder shafts and the obligatory topside wash and wax. Back in the water – our two weeks haul out lasted 6 weeks.

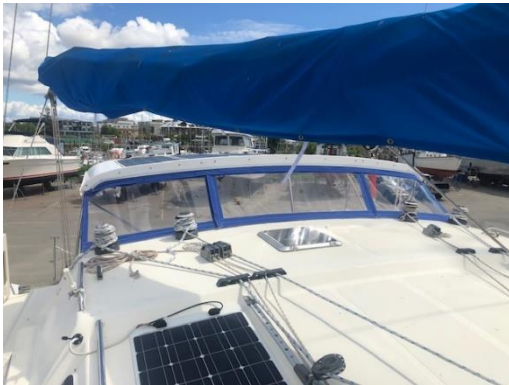
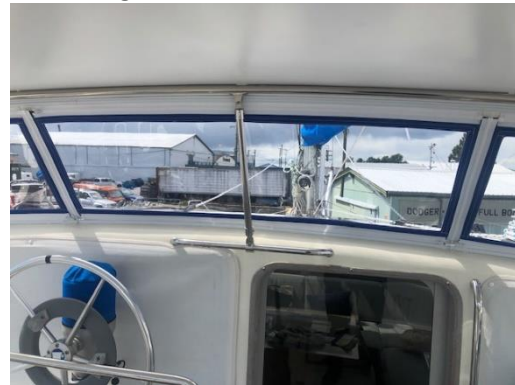
Professionally Built Dodger

We had installed a hard top, built by Tim Postie a year or two back, and did a quick and dirty job adapting the old dodger to the new hardtop. Over the winter Sharon tried to modify the old dodger to fit properly. I thought it was fine – but Sharon was just not happy with the results. Lucky for us, Master Craft Boat Coverings' shop was right next door to the boat. Frank managed to build an awesome new dodger for us within our steadily lengthening time at Strait Marine.

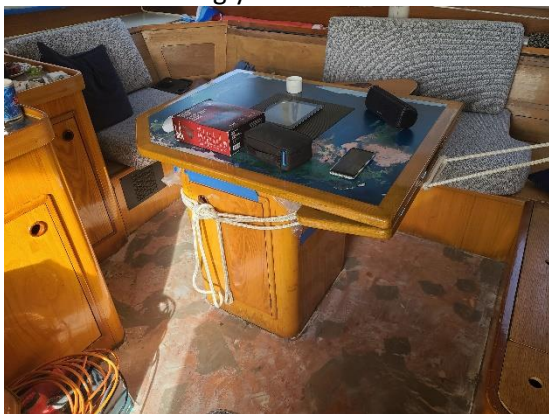
Ugly Salon Floor

Just enough time to sail back across the Salish Sea to our Ladysmith Raven Point marina to strip the old floor tiles out of the salon then sail the boat down to Canoe Cove for our appointment with 3C Yacht Services. 3C had agreed to install the replacement faux mahogany and holly vinyl floor from Plasteak. Buggars! After specifying an *epoxy* filler for floor fairing, the turkey's used a zinc based product that dissolved in water! I've experience with that product, and it turns to mush in high humidity situations in a year or two. No amount of persuading and showing them the manufactures spec's could make them redo it right. Reluctantly I stopped work. We headed back our Raven Point moorage with a disgustingly ugly plywood and resin floor covered with a poorly installed water-soluble filler and a bad taste in our mouths.

Back at our marina (Raven Point in Ladysmith) we met an enterprising young couple who had moved west from Quebec. Stefane has lots of floor installation expertise and agreed to correct 3C's errors and complete the floor installation. His work was outstanding.

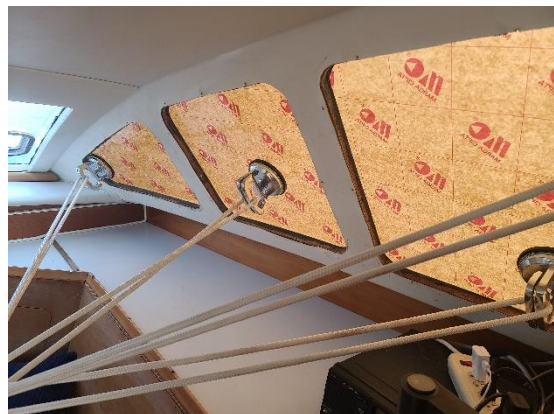
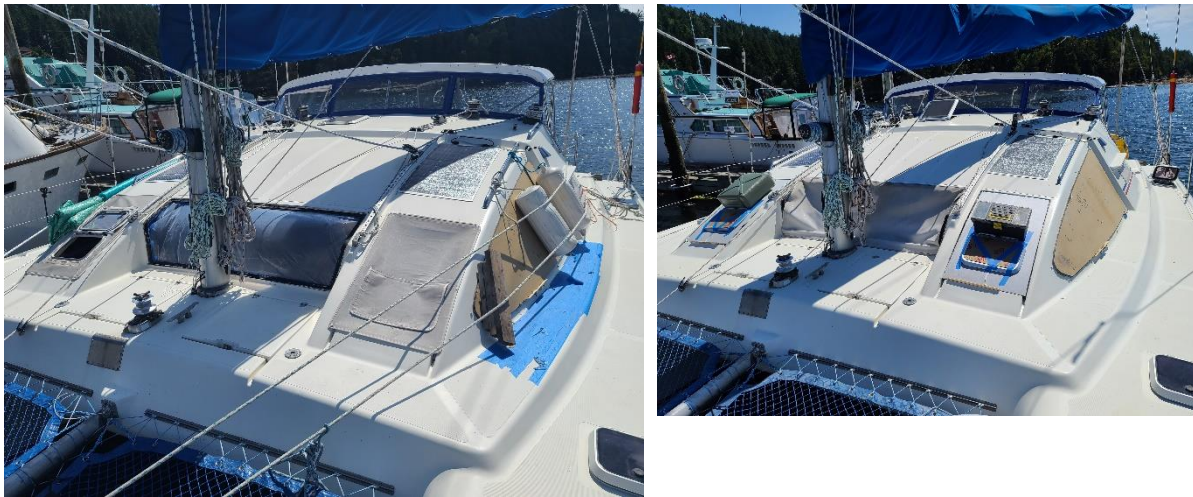
Window Tricks

Our salon windows were crazed from the sun and showing spots and scratches - 32 years of use, much of that in the tropics. Last fall (2020), I lined up Plexi-Klass of Victoria to supply and cut the acrylic glass windows, but the rains had begun so we delayed to this spring. Then COVID travel restriction made our supplier inaccessible. As soon as restrictions were eased, we shelved the floor project and tackled our windows. Vic at Plexi-Klass cut acrylic for the side and smaller front windows

4 of 5 windows new windows removed and re-installed. Arduous work. The Fein tool could break the old Sika bonds, but wedges, chisels and a machete were required to reach the bonds where the Fine tool couldn't reach. Then meticulously scrapping and cleaning the tenacious old Sika off by mechanical means.

To install the big, curved acrylic side windows we used ropes, weights, suction cups and Sika 295 UV (polyurethane) to glue and bend those windows to match the boat's curves. The ropes and weights were left on for 3 weeks to ensure the curves in the acrylic were permanent.

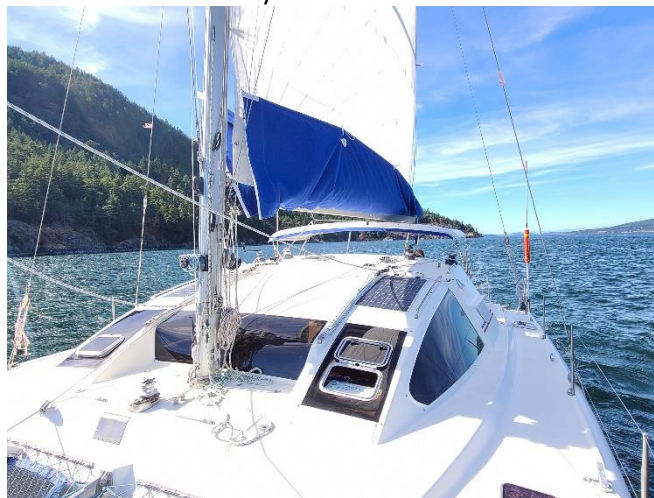
#### Sexy New Windows

Finally, we get the call from Brian, the front window was now finished to his high standard. We brought it back and rough fitted it. Perfect. Awesome

improvement over the old window. Brian eliminated the visual distortion at the major bend in the window. Of course, now the rain starts. A scramble ensued as we rushed to catch the drips and slow the leaks from the unsealed window. The next day, too much wind to primer or safely maneuver the window. Day 3 installation went well.

Brian at Gilcrest Glass Bending in Cobble Hill took on the complex manufacture of the front window. Brian is a perfectionist; he works mainly with tempered glass and sometimes with plastics. He manufactured much of the special glass that Waterline Yachts used in their magnificent line of steel boats. He also supplied complex windows for another cat we know – Sarabi. We waited patiently as Brian meticulously built a custom jig, developed and debugged heating techniques and procedures to create a replacement.
